Manhole Inspection Summary

Manhole # S35EE_020MH

Insp Date: **1/26/08 10:16 AM**

Location Address: **1221 HUNTER ST**

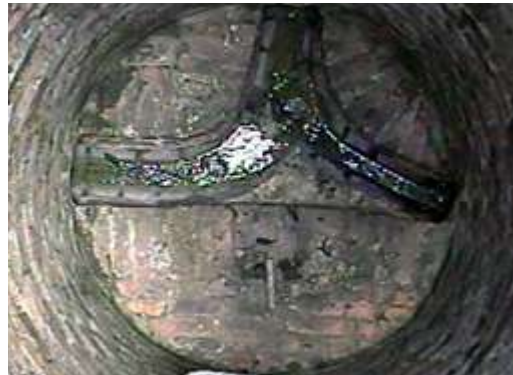
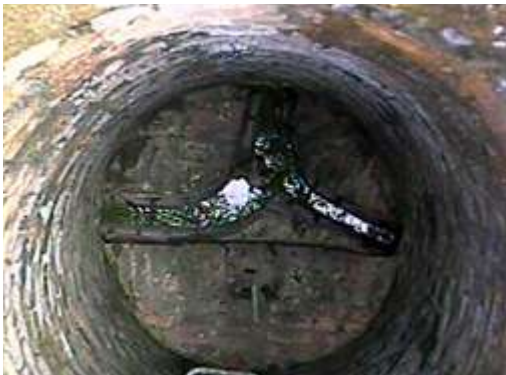
Top View

Type: **Sanitary** Condition: **Sound** Cover Material: **Cast Iron**

Frame Offset: **0** (in.) Condition: ☒ Sound ☐ Cracked ☐ Leaks

Condition: ☒ Sound ☐ Cracked ☐ Root Intrusion ☐ Loose Brick ☐ Deteriorated

Condition: ☒ Sound ☐ Cracked ☐ Root Intrusion ☐ Deteriorated ☐ Leaks ☐ Debris

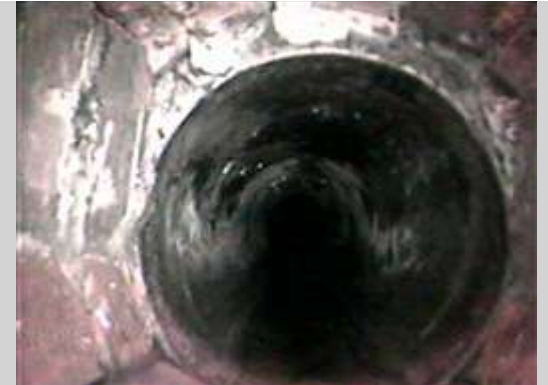
12 O'Clock Outflow

8 in. Circular Gravity Sewer
Pipe Out @ 12 O'Clock

Pipe Height: (in.) Direct
Pipe Material: **Clay** ☐ Pipe Lined
Invert Depth: **8.00** (ft.) Flow Characteristics: **Slow**
Deposits: ☒ None ☐ Mud ☐ Sludge ☐ Debris ☐ Grease
Silt Depth: (in.) Deposits Extent:
Infiltration: **None** Pipe Seal Cond: **Sound**

Drop: **None**

Connects To: **Manhole**

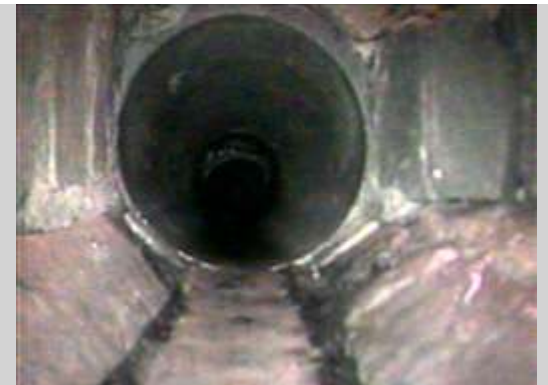
3 O'Clock Inflow

6 in. Circular Gravity Sewer
Pipe In @ 3 O'Clock

Pipe Height: (in.) Direct
Pipe Material: **Clay** ☐ Pipe Lined
Invert Depth: **7.90** (ft.) Flow Characteristics: **Slow**
Deposits: ☒ None ☐ Mud ☐ Sludge ☐ Debris ☐ Grease
Silt Depth: (in.) Deposits Extent:
Infiltration: **None** Pipe Seal Cond: **Sound**

Drop: **None**

Connects To: **House connection / Service line**

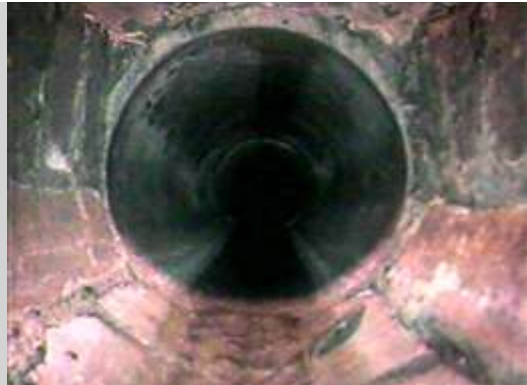
9 O'Clock Inflow

8 in. Circular Gravity Sewer

Pipe In @ 9 O'Clock

Pipe Material: **Clay** ☐ Pipe Lined

Invert Depth: **7.80** (ft.) Flow Characteristics: **Slow**

Deposits: ☒ None ☐ Mud ☐ Sludge ☐ Debris ☐ Grease

Infiltration: **None** Pipe Seal Cond: **Sound**

Drop: **None**

Connects To: **Manhole**
